INDOOR AIR QUALITY ASSESSMENT

**Westminster Town Hall
3 Bacon Street
Westminster, Massachusetts**

Prepared by:
Massachusetts Department of Public Health
Center for Environmental Health
Emergency Response/Indoor Air Quality Program
November 2005

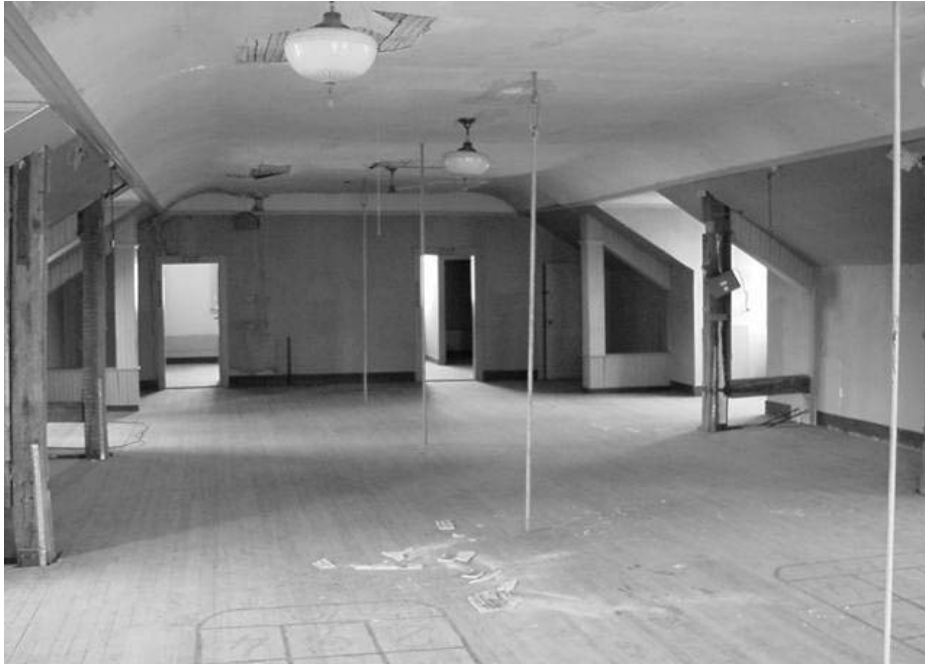
Picture 1

The town hall had undergone major structural refitting to preserve the structural soundness of the building. Substantial stabilization and repairs to portions of the roof and uppermost level were done in 2000. The topmost level contains a series of iron tie rods (Pictures 1 and 1A) that connect the floor/auditorium ceiling to the ridge beam of the roof. This design would transfer the weight of the floor/auditorium ceiling and materials on the floor (called load), which would pull downward on the roof peak. This load would then be transferred to the roof rafters, which would then push outward on the exterior wall of the building. In order to provide roof support, horizontal beams connected to the rafters were inserted into a vertical wooden beam (called and mortise and tenon joint)

Tie Rods Connecting Auditorium Ceiling to the Roof

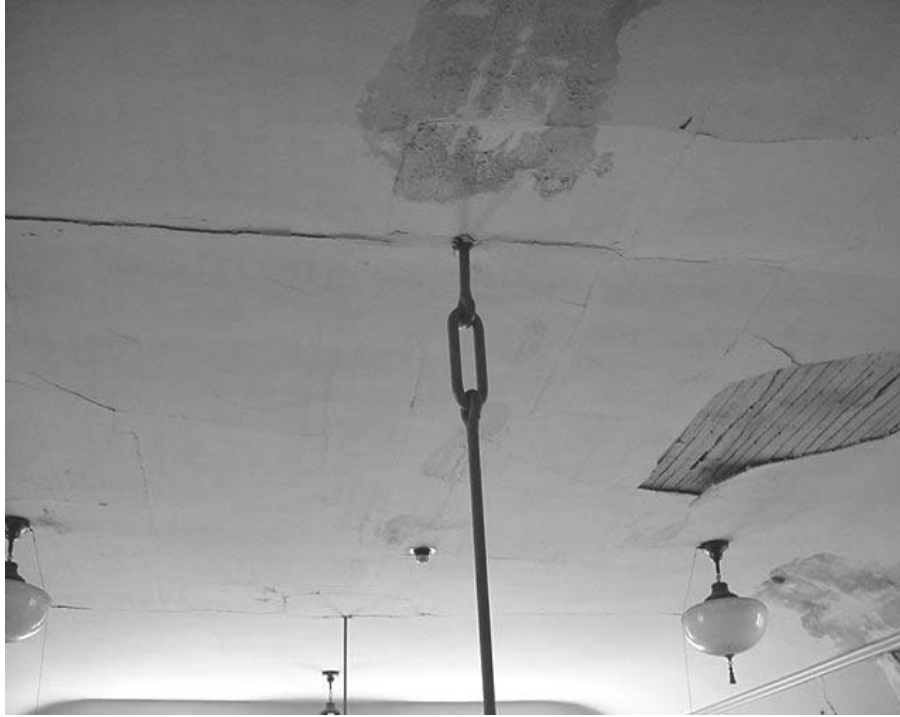
Picture 1A

Close-Up of Tie Rod in Picture 1

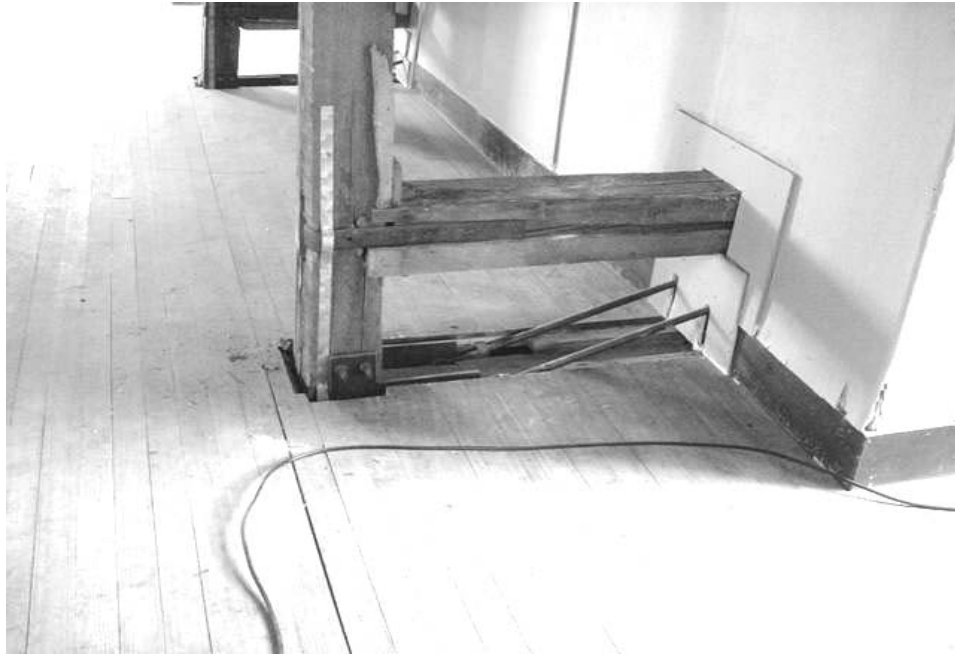
Picture 2

**Wooden Horizontal Beam Inserted In Slot of Wooden Vertical Beam (mortise and tenon joint)
(Note Crack in Vertical Beam)**

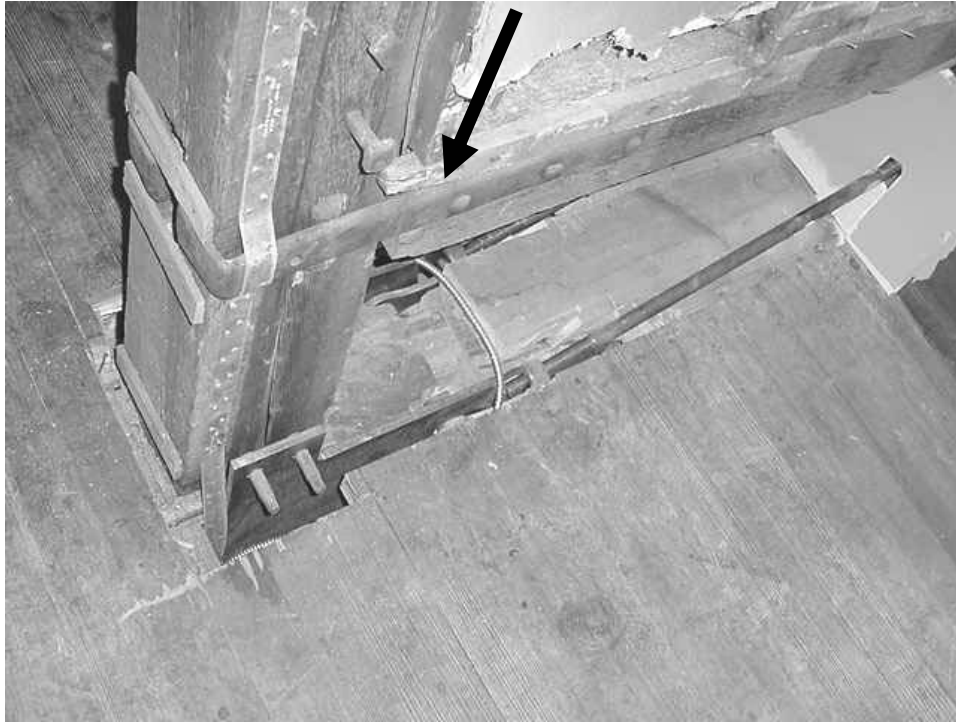
Picture 3

(Figure 1) (Picture 2). The mortise and tenon joints were held in place by a metal strap wrapped around the vertical beam and nailed into the horizontal beam with metal spikes (Picture 3). In this fashion, the outward thrusting of the roof rafters would be arrested by these horizontal/vertical beams.

Original Metal Strap Spiked Into Place That Holds Horizontal and Vertical Horizontal Beams Together

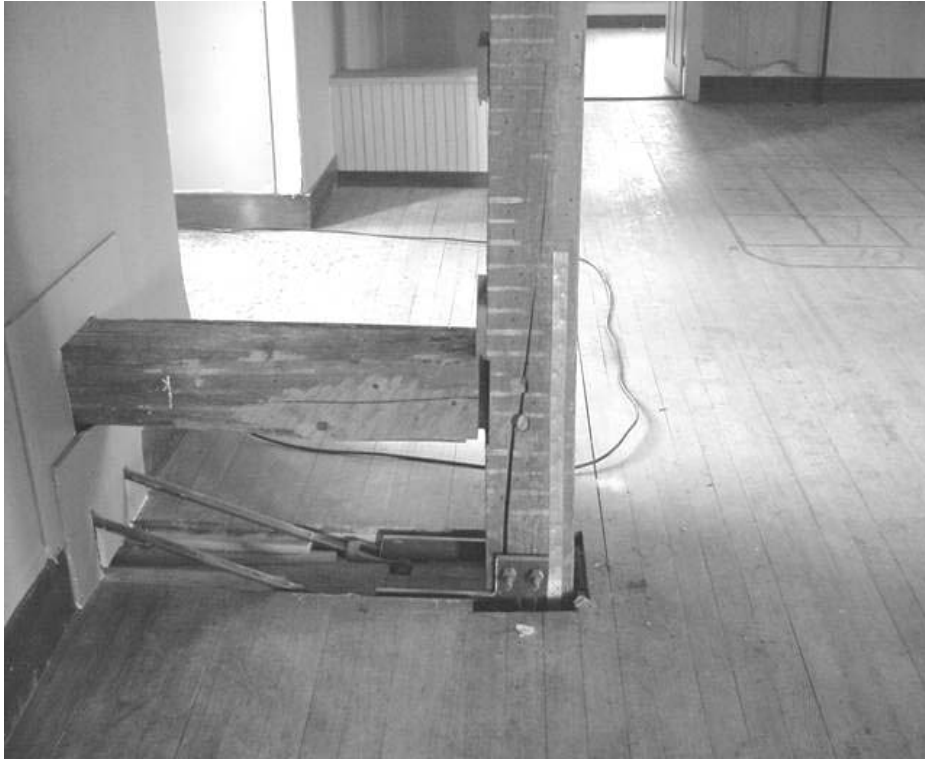
Picture 4

At some point previous to the assessment, a combination of heavy snow on the roof, combined with the weight of materials stored on the uppermost floor exceeded the capacity for the wooden vertical beams to carry load. This conclusion is supported by the following conditions noted in and outside the town hall.

- A number of vertical beams were either cracked at or around the iron strapping (Picture 4). Once a beam cracks, its ability to bear load is significantly reduced.

Cracked Vertical and Horizontal Beam

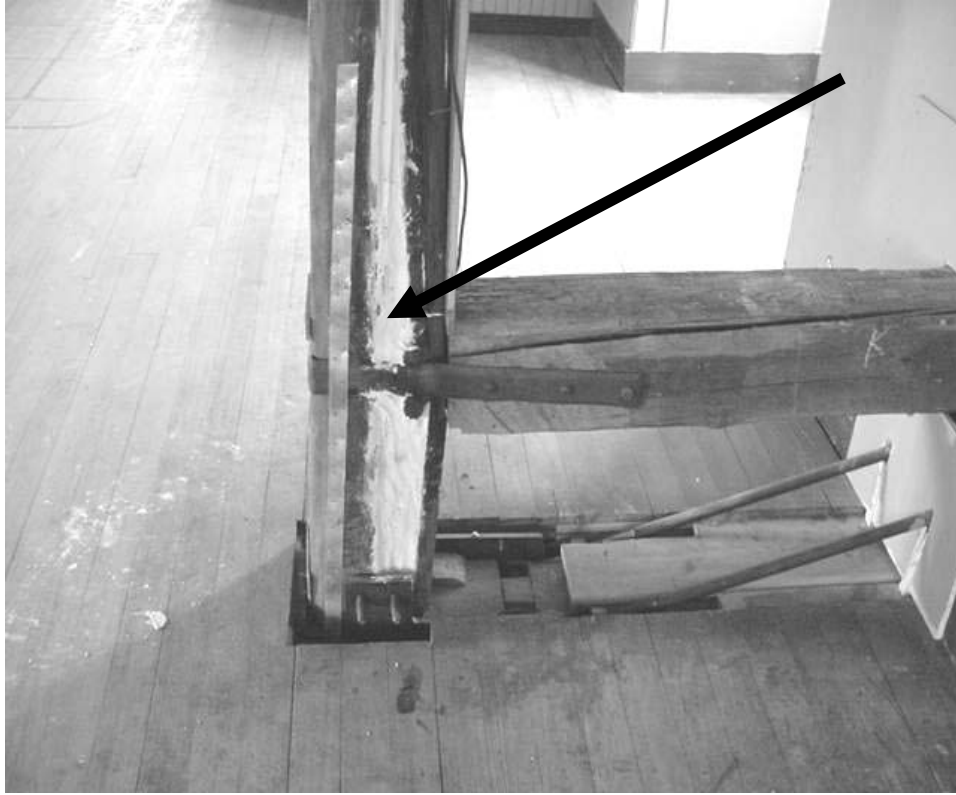
Picture 5

- One vertical beam had split entirely. It appears that a type of composite compound was applied to re-establish the integrity of the beam (Picture 5).

Cracked Vertical Beam Reformed With Composite Compound (Arrow)

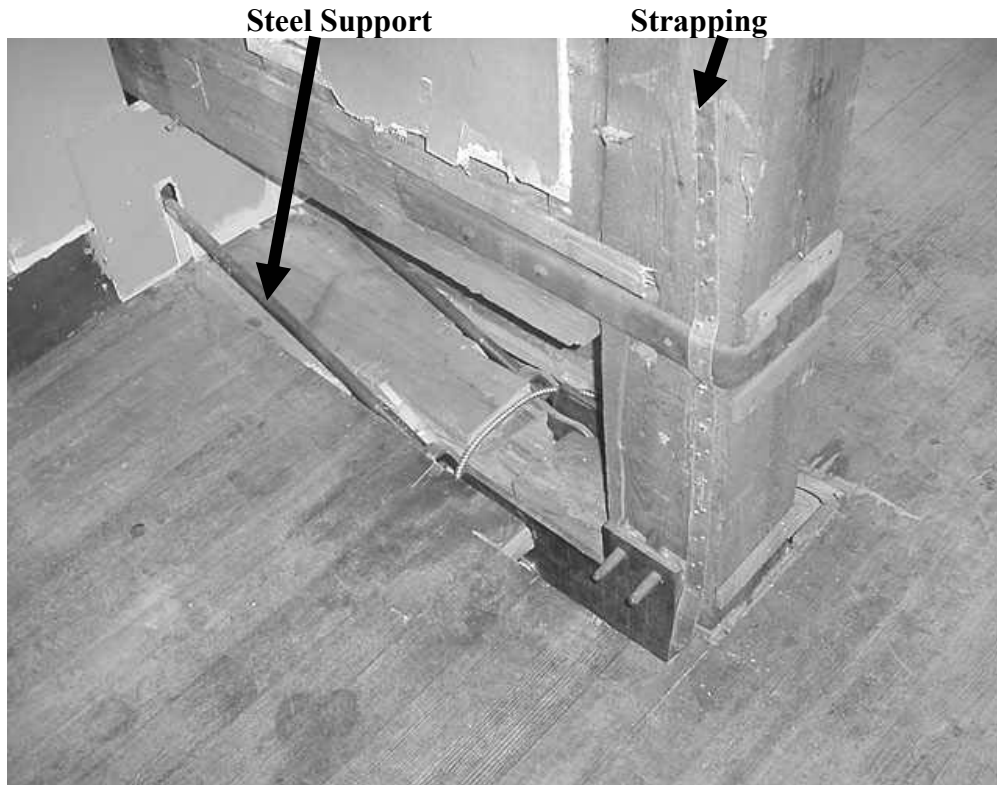
Picture 6

- Supplemental steel supports (Picture 6) appear to be connected to the roof edge to the vertical support beams.
- A gap, (estimated to be 2 inches) exists between the auditorium ceiling and gypsum wallboard (GW) used to subdivide the auditorium (Picture 7). Since GW has minimal elastic quality and is extremely susceptible to compression, this gap appears to have been created when the repairs to the beams raised the ceiling *upwards*.

Supplemental Steel Supports and Strapping (Arrows) Installed To Reinforce Horizontal and Vertical Beams

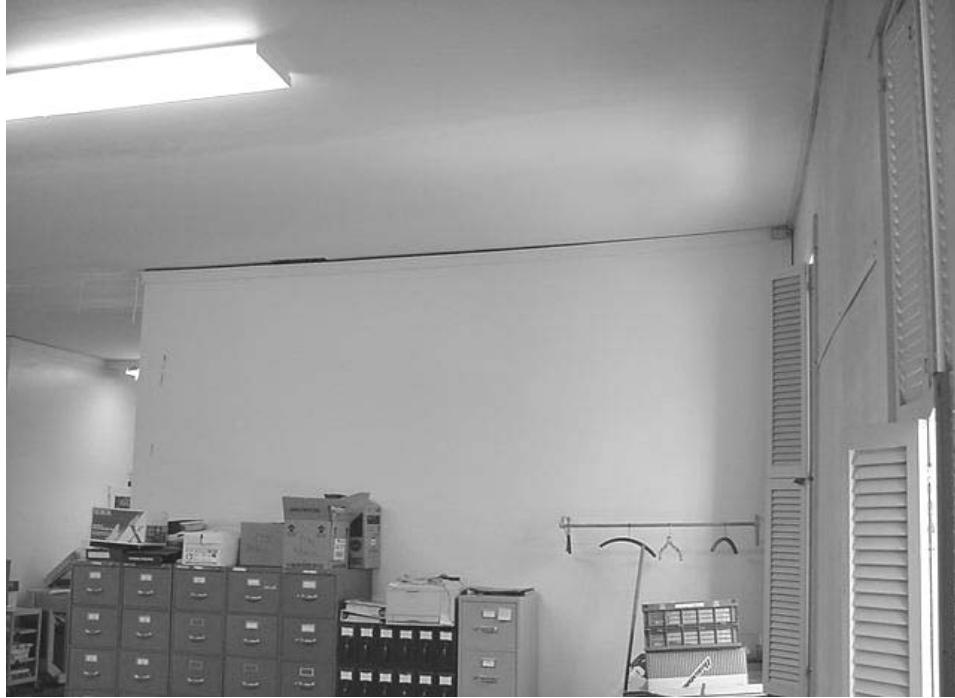
Picture 7

Gap Created By Repair Lifting Ceiling

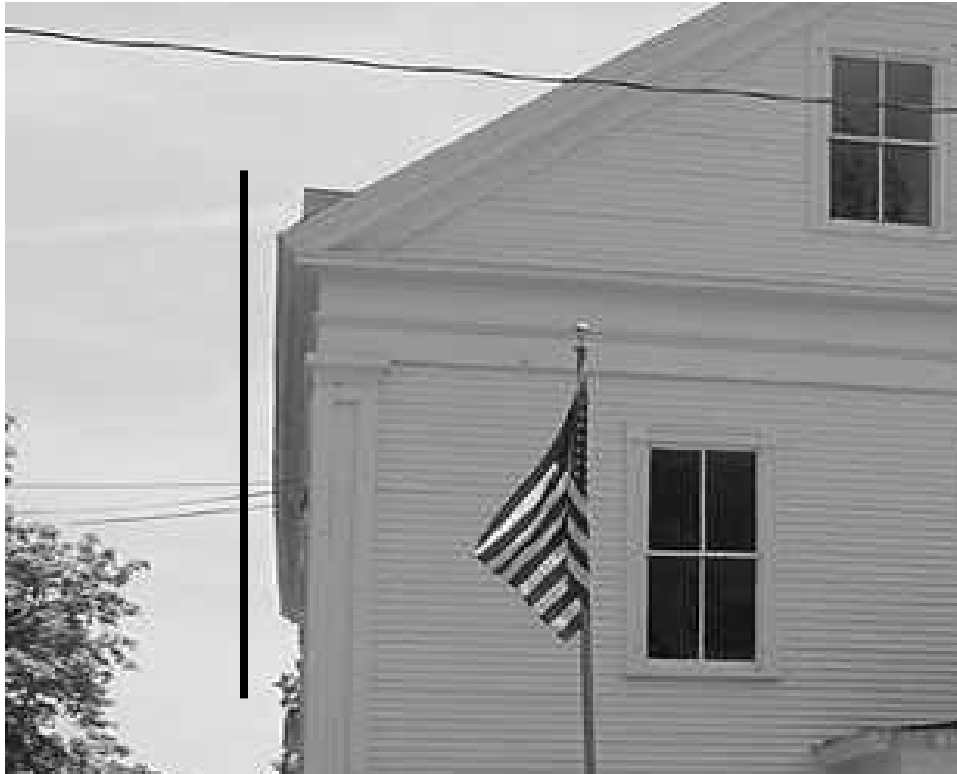
Picture 8

- The north second floor wall appears to bulge outwards when examined from the northwest corner of the building (Picture 8). This bulging roughly corresponds to the worst beam damage noted on the uppermost level.

Bulging Second Floor Exterior Wall/Roof Edge, North Side (Line Added As Visual Aid)

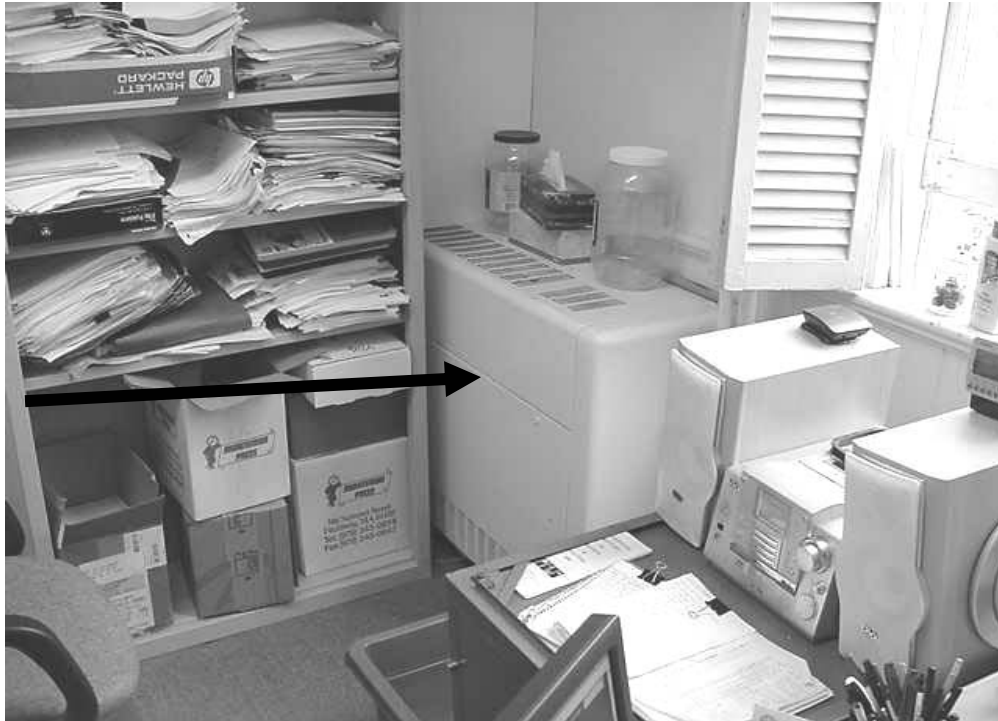
Picture 9

Univent with Wall Installed Over Casing

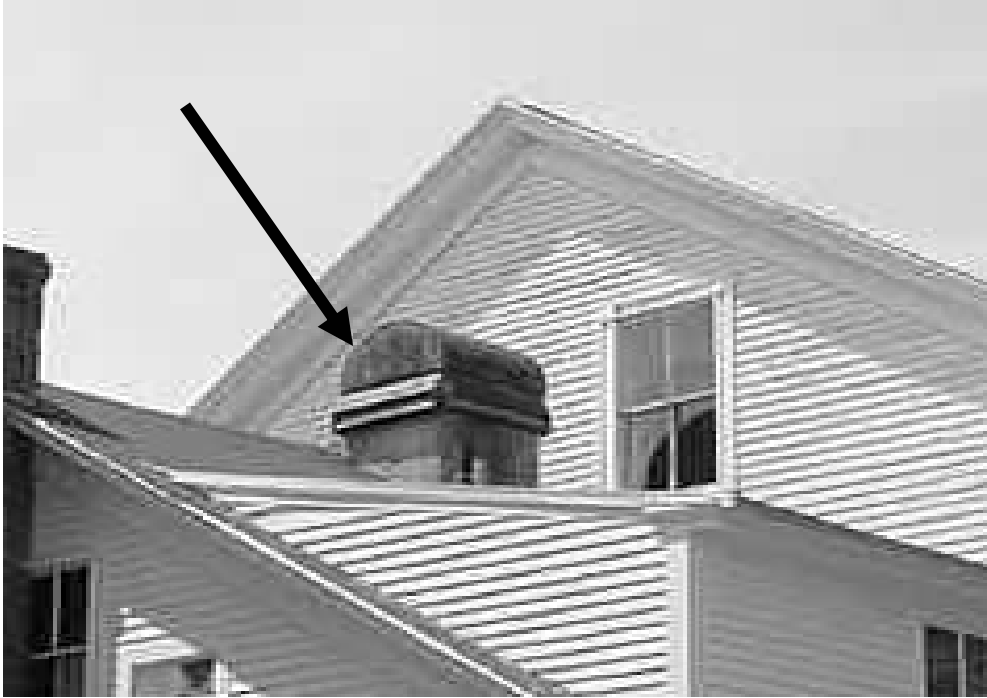
Picture 10

Exhaust ventilation in the first floor is provided by a ducted hallway vent which is likely connected to a fan above the furnace room (Picture 10). This vent was sealed with plywood (Picture 11) and the fan appeared to be deactivated. Without functional mechanical supply or exhaust ventilation, environmental pollutants can accumulate within the building and lead to poor air quality/comfort complaints. To maximize air exchange, the MDPH recommends that windows be used to provide airflow during business hours.

Exhaust Vent Housing on Roof

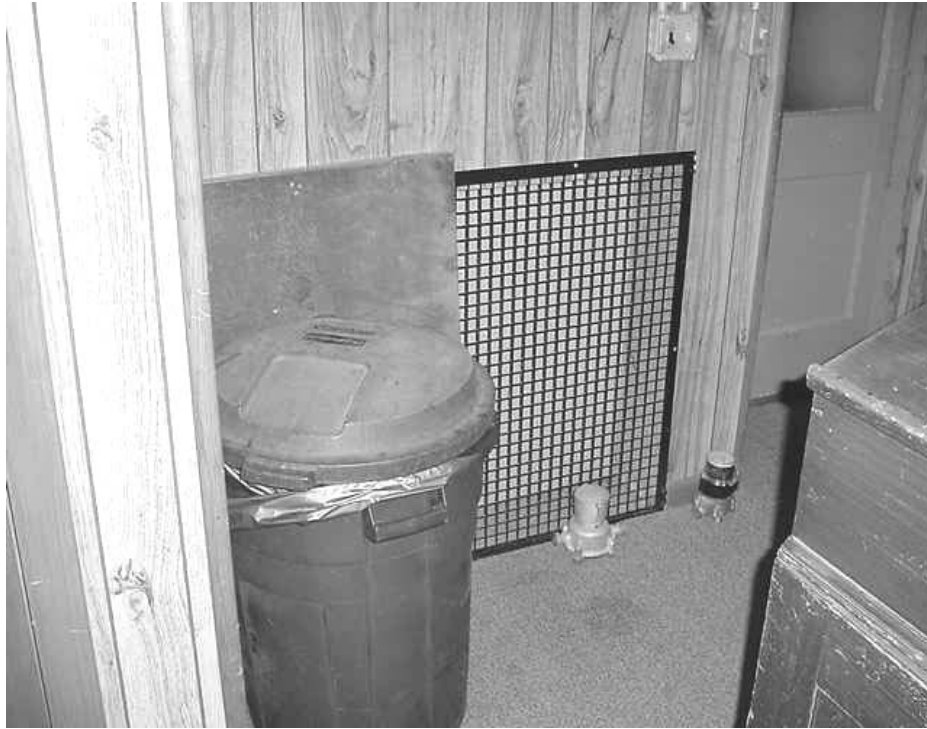
Picture 11

Exhaust Vent, First Floor, Note Plywood Blocking Vent

8. Remove all blockages from univents and exhaust vents.
9. Operate both supply and exhaust ventilation continuously during periods of occupancy.
10. Consider having ventilation systems re-balanced/calibrated every five years by an HVAC engineering firm.

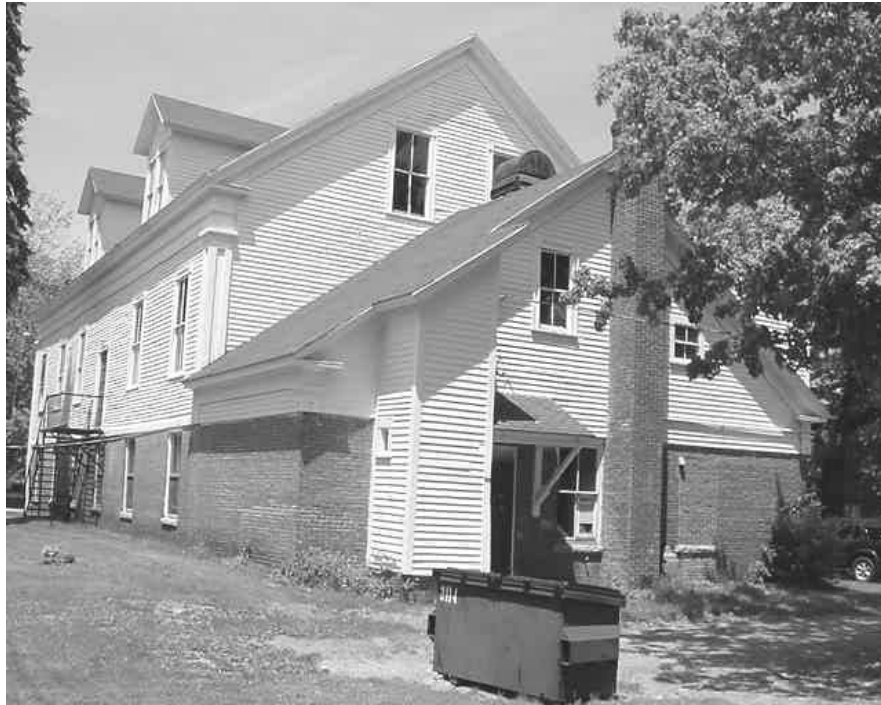
Picture 12

The absence of a gutter/downspout system (Pictures 12 and 13) may have a role in water accumulating in the building, particularly under the building commissioner's office. The exterior brick walls along the north side of the first floor are stained green with moss at approximately three feet above ground level, indicating chronic exposure to splashing rainwater from the non-guttered roof. Along the edge of the foundation of the town hall are a series of pits (Picture 14) as well as a tarmac apron. The purpose of these pits is to provide passive ventilation for the crawlspace to prevent odor and moisture accumulation. Each of these crawlspace vents was sealed with plywood and the seams caulked with foam insulation material (Picture 15). According to Board of Health personnel, the vents were sealed in this manner to prevent intrusion by pests (e.g., rodents). By blocking these vents, water vapor and other crawlspace pollutants will tend to vent *into* the building creating odors and moisten building components. In addition, buildings are normally constructed to allow for water to flow away from exterior walls, particularly if the building has a crawlspace or cellar. The purpose of the tarmac apron is to direct rainwater away from the exterior walls. The tarmac apron was buried under soil on the south wall and damaged along the north wall in a manner that allows for water to accumulate against the foundation (Pictures 16 and 17). In both instances, water is likely to accumulate against the exterior wall and penetrate the crawlspace.

No Gutter/Downspout on Roof Edge, South Wall

2. Remove plywood from crawlspace vents to enhance airflow. Install wire mesh over each opening to prevent pest infiltration.
 3. Install a gutter and downspout system along the roof edge.

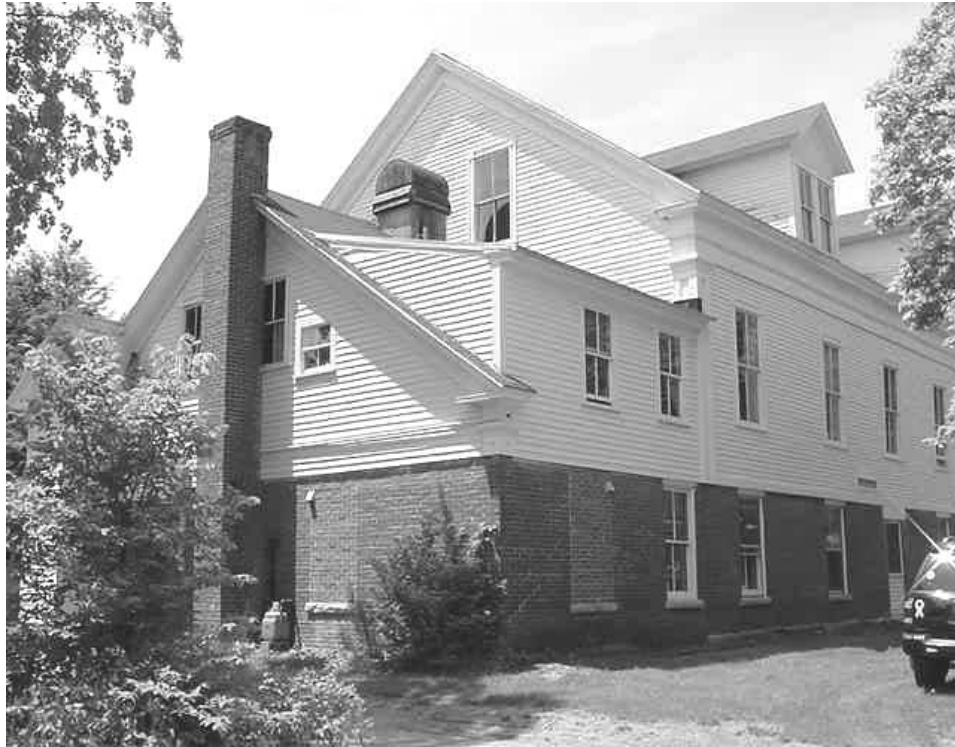
Picture 13

No Gutter/Downspout on Roof Edge, North Wall

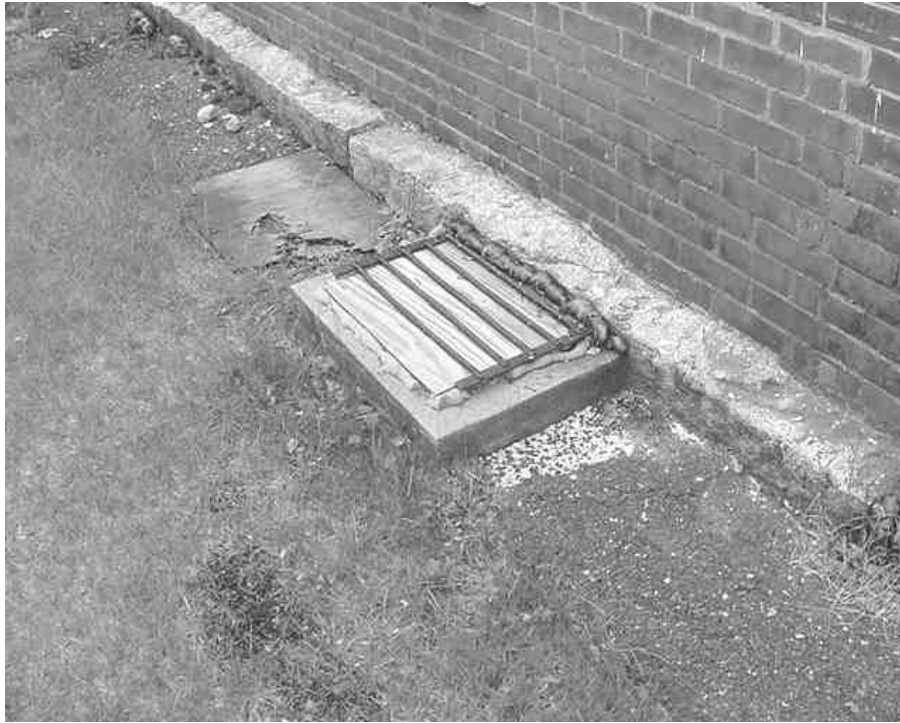
Picture 14

Crawlspace Vent Pit at Base of the Building, Note Plywood and Sealant

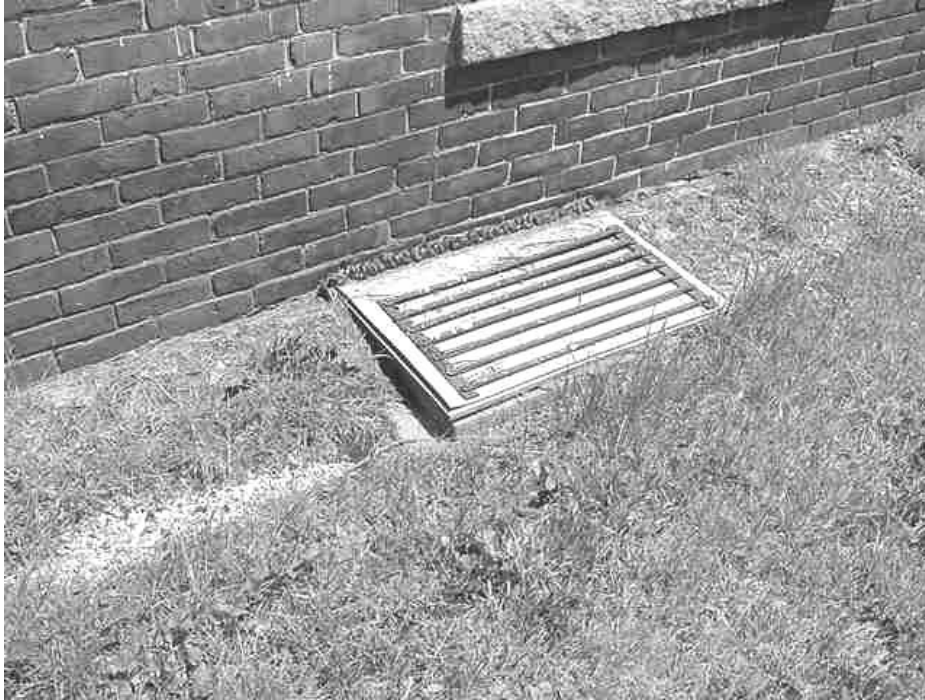
Picture 15

commissioner's office. A blocked crawlspace vent exists just outside the window for this office, which is directly exposed to driving rain from the south/southwest. The other crawlspace vent on this side of the building is generally sheltered by a large pine tree in the southwestern corner of the town hall's lot. Therefore, it appears likely that rainwater is accumulating beneath the building commissioner's office, which as it evaporates, may increase the relative humidity in this office (the relative humidity measured during the assessment was higher than that outdoors).

**Crawlspace Vent Sealed with Plywood and Sealant Adjacent to Building Commissioner's Office, Note
Tarmac Apron Overgrown with Grass**

4. Until a gutter and downspout system can be installed, construct temporary, water proof shelters over each crawlspace vent to prevent water intrusion

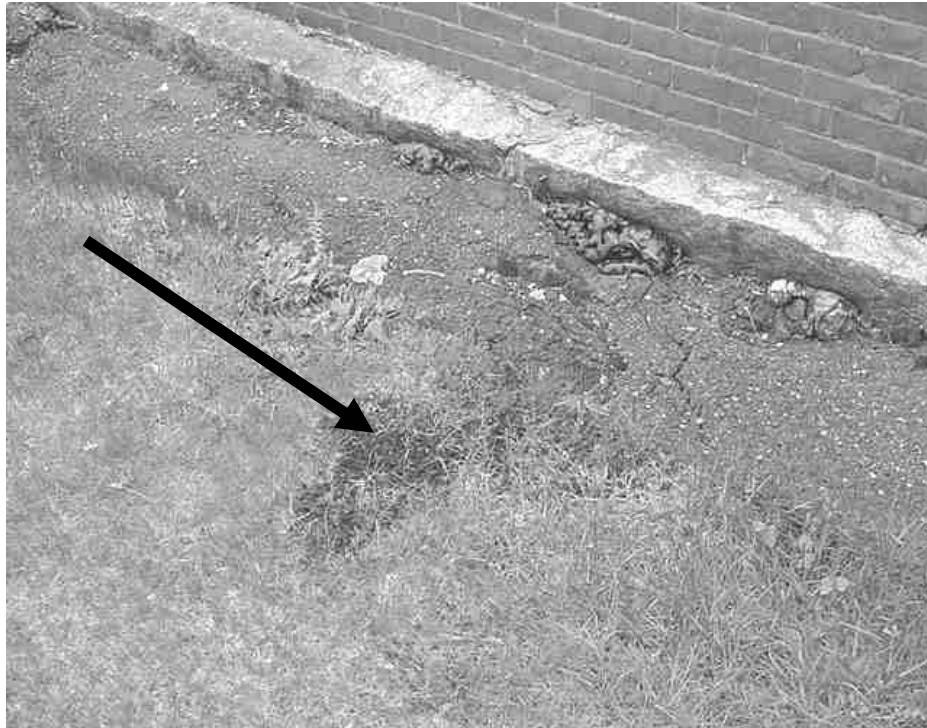
Picture 16

Damage Tarmac Apron, North Exterior Wall, Note Moss in Grass (Arrow) Indicating Heavy Water Exposure in This Area

6. To prevent moisture penetration into the crawlspace, the following actions should be considered:
 - a. Reestablish the integrity and grade of the tarmac apron to drain rainwater from the foundation.

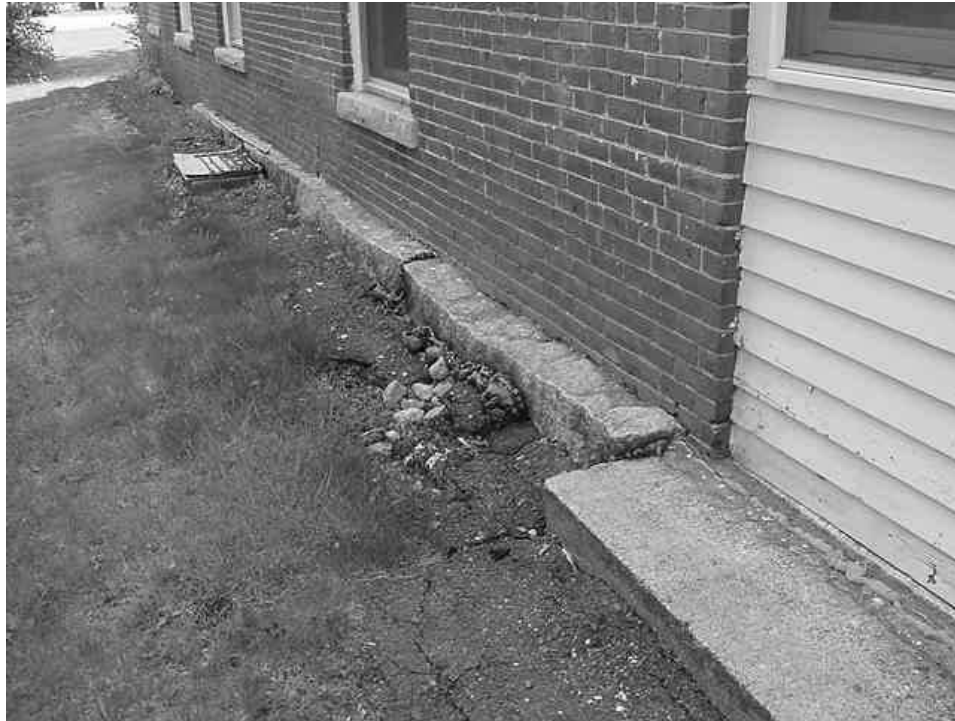
Picture 17

Damage Tarmac Apron, North Exterior Wall

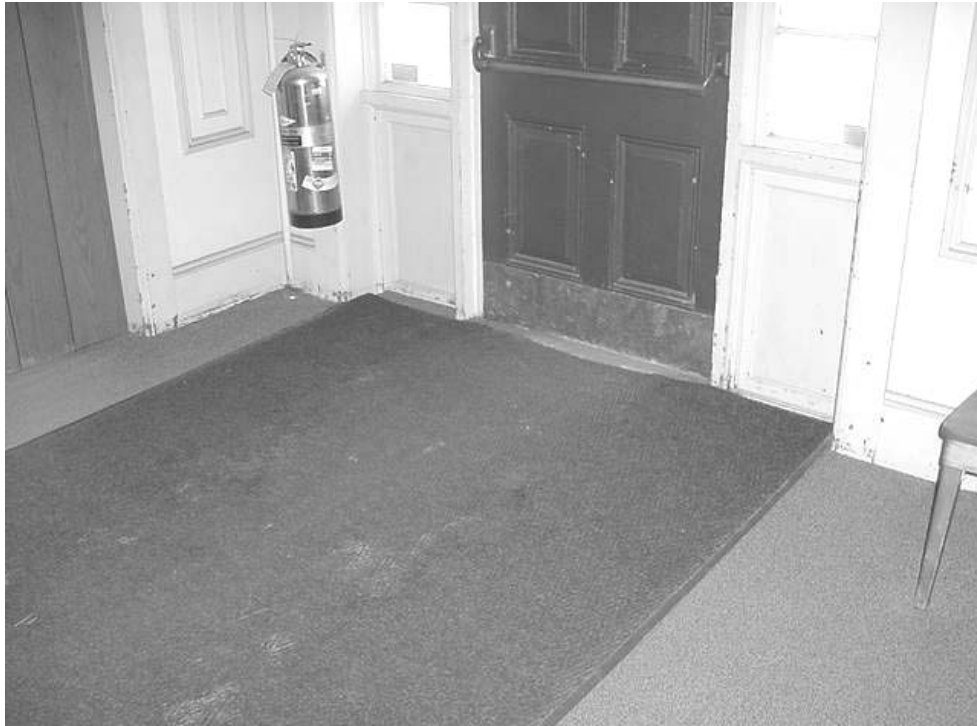
Picture 18

A musty odor was noted upon entering the town hall. A walk-off carpet exists at the main entrance, which is installed over wall-to-wall carpet (Picture 18). The rubber matting of the walk-off carpet tends to trap moisture and preventing the carpeting from drying. It is likely that the source of musty odors is the wall-to-wall carpet. Please note that the carpeting is installed over a tile floor. Old floor tile may contain asbestos and should be remediated in a manner consistent with Massachusetts asbestos laws.

Walk-Off Carpet On Top Of Wall-To-Wall Carpet, Front Lobby

13. Ascertain whether tile under carpet contains asbestos and remediate in a manner consistent with state and federal laws related to asbestos.
